EVALUATION OF SURFACE TREATMENT TEST PITS

D.R. MURRAY AND H. WILLETT

NOVEMBER 1982

MINERALS RESEARCH PROGRAM
MINING RESEARCH LABORATORIES
DIVISION REPORT MRP/MRL 82-145 (TR)

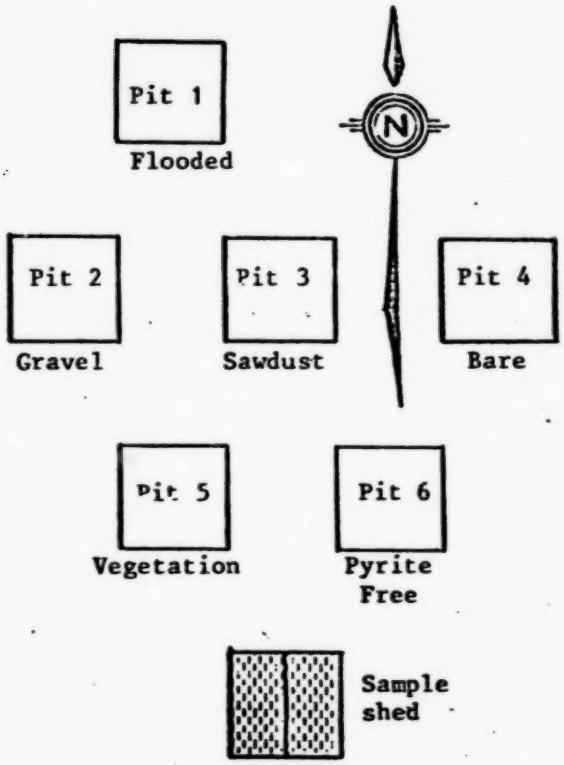
Fig. 3 - Pit layout.

The arrangement of the new drainage system is shown in Fig. 3.

Fig. 3 - Modified pit drainage system for easy servicing.

over the cut part of the line. Sand and gravel were backfilled outside the box. A section of pipe was removed and the two ends joined with a removable section of pipe. Stainless steel jackets with a neoprene sleeve provided suitable couplings, making it possible to easily remove the pipe section for future servicing and not permit any internal obstruction to the water flow. A lid was securely placed on the top of each box. The drainage lines were then left free draining while water flow rates were made and grab water samples were taken for analysis.
